Fractured Lead Case Study

By James Strickland, MD
Heart Rhythm Associates

History of Present Illness (HPI)

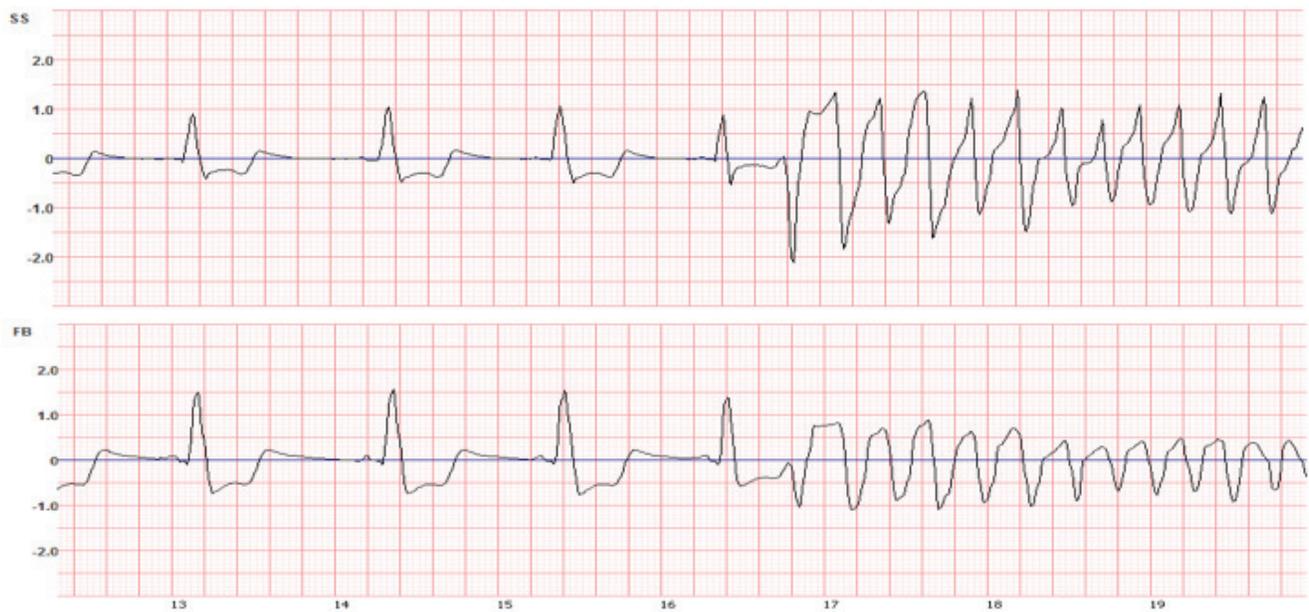
Two weeks prior to the scheduled lead extraction/replacement procedure, the patient experienced an episode of ventricular flutter which progressed to ventricular fibrillation (VF) (Figure 1).

Figure 1: ECG downloaded from the WCD. The WCD continuously monitors the patient's ECG using a 4 electrode, 2 lead system: side-to-side (SS, top) and front-to-back (FB, bottom)

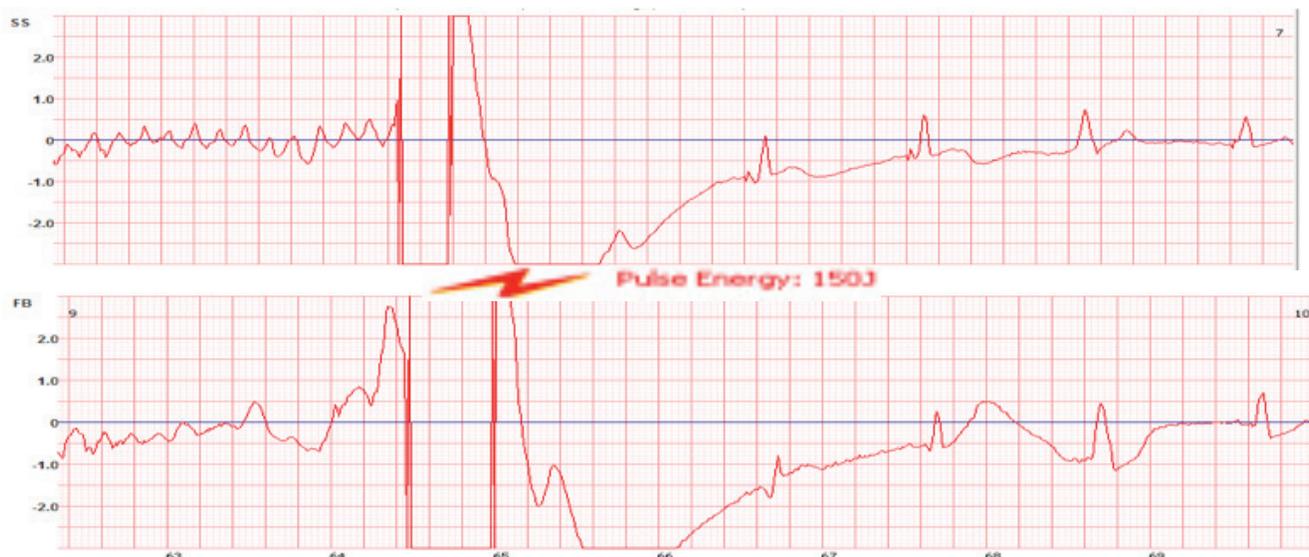
The patient's WCD appropriately detected the episode, and delivered a 150J biphasic treatment shock 48 seconds later (Figure 2). The treatment successfully converted his VF to a normal sinus rhythm at a rate of 61 BPM. The patient was instructed to continue to wear the WCD until his scheduled lead extraction.

Figure 2: ECG downloaded from WCD displaying a 150J biphasic treatment shock which successfully converted the patient's VF to a normal sinus rhythm at a rate of 61 BPM.
